# Technical Report

## ROM UPGRADE..... (10)

**1. Model Name:** BP-C131WD, BP-C131PW

**2. Description:** Upgrade of MCU-MAIN, PCU -ROM

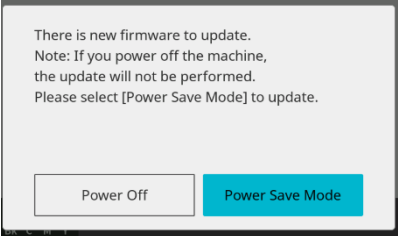
| No. | Item | Detail |
|---|---|---|
| 1 | Specification | <p>Changed the notification behavior when the power is turned off while online firmware update is enabled.</p> <p>■ Message displayed when updated firmware is available at power-off:</p> <p>There is new firmware to update.</p> <p>Note: If you power off the machine, the update will not be performed.</p> <p>Please select [Power Save Mode] to update.</p> <p>[Power Off][Power Save Mode]</p> |
