Technical Report

ROM UPGRADE..... (26)

1. Model Name: BP-50C26/31/36/45/55/65, BP-55C26, BP-60C31/36/45, BP-70C31/36/45/55/65, BP-50M26/31/36/45/55/65, BP-70M31/36/45/55/65, BP-FR12U (Option for BP-50C26/31/36/45/55/65, BP-55C26, BP-60C31/36/45, BP-70C31/36/45/55/65, BP-50M26/31/36/45/55/65, BP-70M31/36/45/55/65)

2. Description: Upgrade of FAX

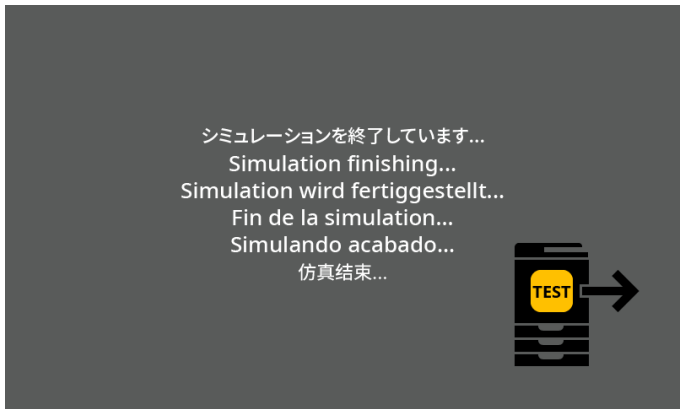
61	Specification	<p>Change of the screen displayed at the time of reboot from the simulation (Addition of Chinese and correction of the translation/ addition of the icon).</p>

<p>The screenshot shows a dark gray background with white text. The text is arranged in a list-like format, showing the simulation finishing in various languages: Japanese (シミュレーションを終了しています...), English (Simulation finishing...), German (Simulation wird fertiggestellt...), French (Fin de la simulation...), Spanish (Simulando acabado...), and Chinese (仿真结束...). To the right of the text is a yellow button with the word 'TEST' in black, and a black arrow pointing to the right.</p>

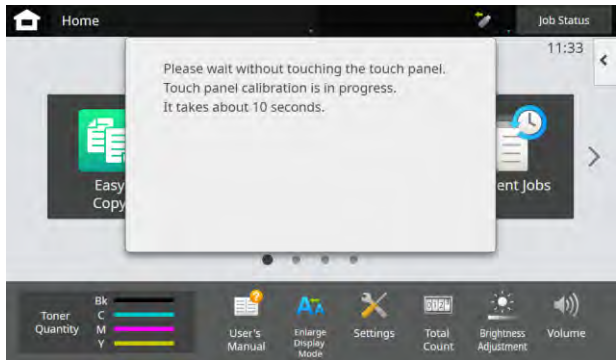
No.	Item	Detail
1	Specification	<p>Auto execution of touch panel calibration has been implemented to prevent false operation.</p> <p>*The touch panel is locked and auto calibration (sensitivity adjustment) is executed to prevent false operation when abnormal touch information is detected and the noise comes from AC power or fax line or LAN cable is significant.</p> <p>*The message "Please wait without touching the touch panel. Touch panel calibration is in progress. It takes about 10 seconds." appears during auto calibration.</p>

<p>The screenshot shows a touch panel interface with a central message box that reads: "Please wait without touching the touch panel. Touch panel calibration is in progress. It takes about 10 seconds." The interface includes a top bar with "Home" and "Job Status" buttons, a bottom bar with various icons (Toner, User's Manual, Enlarge Display Mode, Settings, Total Count, Brightness Adjustment, Volume), and a background with "Easy Copy" and "Recent Jobs" icons.</p>

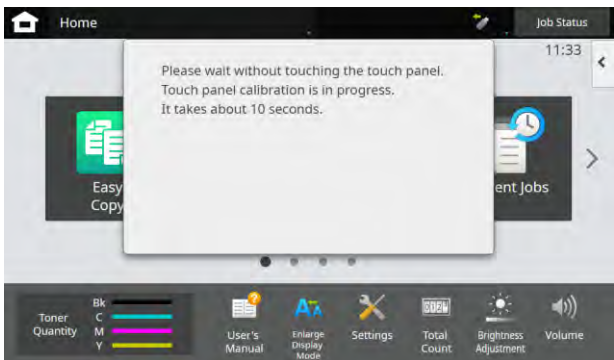
No.	Item	Detail
1	Specification	<p>Auto execution of touch panel calibration has been implemented to prevent false operation.</p> <p>*The touch panel is locked and auto calibration (sensitivity adjustment) is executed to prevent false operation when abnormal touch information is detected and the noise comes from AC power or fax line or LAN cable is significant.</p> <p>*The message "Please wait without touching the touch panel. Touch panel calibration is in progress. It takes about 10 seconds." appears during auto calibration.</p>

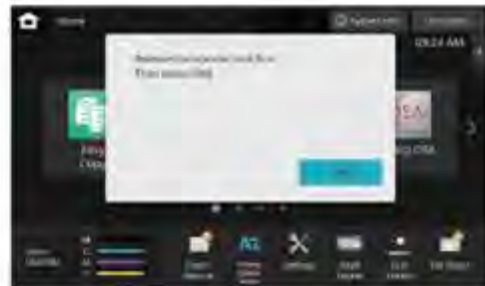
- 7) Press OK.

- 8) MFP Automatically rebooted and enters the toner replenishment operation.

Confirm that "Toner replenishment in progress" is displayed and wait until the display disappears. (it takes 30 sec - 4min)
